PHASE I ENVIRONMENTAL ASSESSMENT

Desimone/Oxblow Freemont
2600 South 102nd Street and 10110 - 10180 West Marginal Place
Tukwila, King County, Washington 98168

December 15, 2004

Property Solutions Project No. 20042586

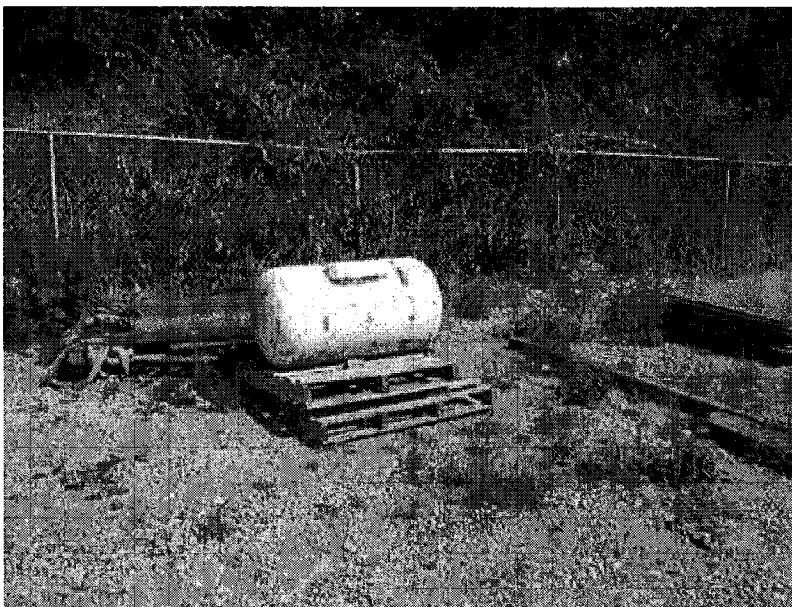
PHOTO 14. Empty AST

No active aboveground storage tanks (ASTs) were observed on the subject property during the property visit. One inactive and empty propane AST was observed on the subject property. The propane AST is not expected to have adversely impacted the environmental condition of the subject property.

Based upon the above information, no further action is recommended.
